Revisiting the Mosaic of the Masks on Delos: a Comprehensive Condition Survey

Revisiting the Mosaic of the Masks on Delos: A Comprehensive Condition Survey

Styliani Minetou¹, Christos Maris^{1,2}, Ioannis P. Staikopoulos²,
Stefania Chlouveraki^{1*},

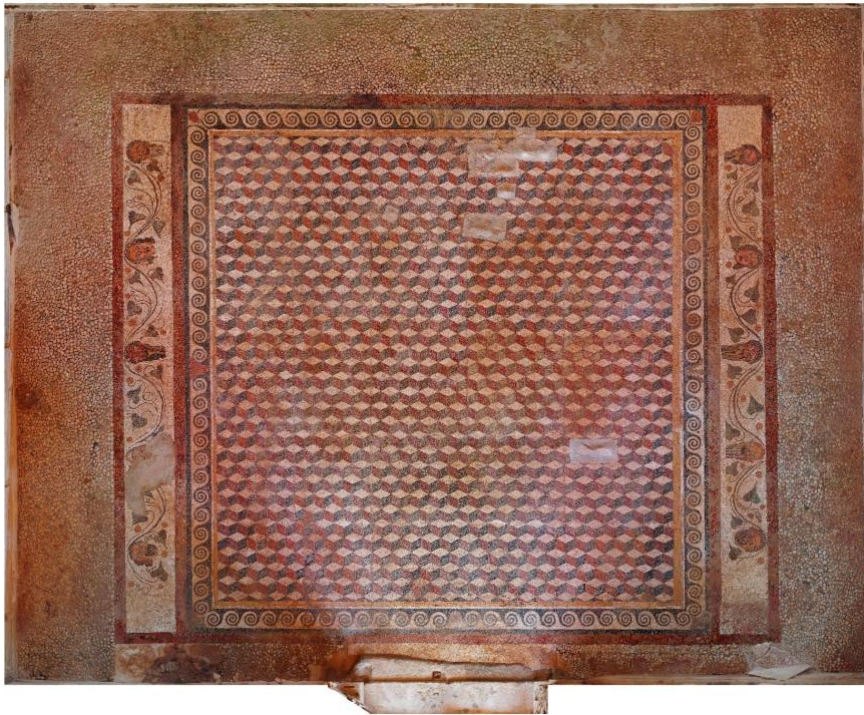
The mosaic under study, measures 9.12 x 7.09 meters and features a central geometric pattern consisting of '3D cubes', a recurring geometric pattern in Hellenistic mosaics, characterized by the depiction of cubes arranged in a three-dimensional manner. The central pattern is bordered by a decorative band of waves, with two lateral bands on the east and west, each showcasing five theatrical masks, interwind with floral motifs. The outer band is plain giving the illusion of a big carpet on the room (Fig.1).

Fig. 1. Orthophoto of the mosaic of the Masks, 9.12 x 7.09 meters (by C. Maris)

Both handheld digital cameras and drones were utilized to capture images. A first set of 974 images were acquired before cleaning, followed by a set of 857 images after dry cleaning. The first two sets of images were shot from a height of approx. 0,5 m, with a 70% overlap, a rather a time-consuming and labor-intensive process. Image processing was similarly challenging due to the large number of images. A third set of 187 images were acquired with a drone from a steady distance of 3 m. The orthophotos and the digital elevation model (DEM) provided metric information and enabled the study and documentation of surface geometry alterations related to natural deterioration and to previous conservation treatments. Moreover, the orthophotos served as a base for the accurate mapping of surface and structural conditions (**Fig 1-2**).

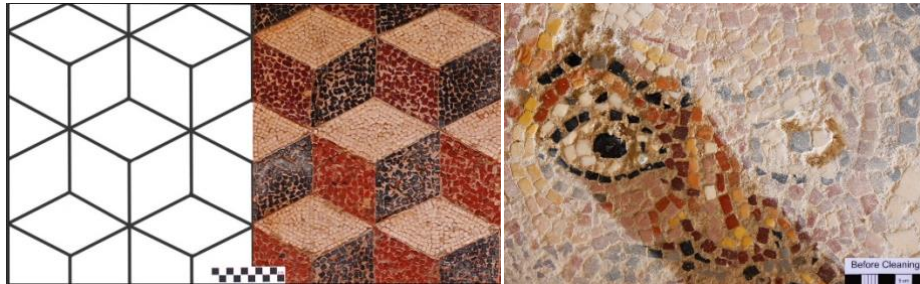
A variety of materials and fabrication techniques are employed. The sides of the cubes are set in *opus segmentatum*, characterized by the random setting of irregular red and

black tesserae with wide and irregular interstices (Fig. 2). In contrast, the top of the cubes is set in *opus tessellatum* characterized by a well-organized *andamento*, using white tesserae of approx. 1 cm side arranged in concentric lozenges [3]. Additionally, lead strips [4,5] are used to define the sides of the rhombuses that form the three-dimensional cubes and the outlines of the waves. *Opus vermiculatum* is used in the masks and *opus tessellatum* in their background, the floral motifs and the rest of the decorative bands. Glass tesserae are used in a few details of the masks while the rest of the mosaic is made of stone tesserae.

Fig. 2. Detail of the 3D cube pattern of the central mosaic carpet (photo and drawing by S. Minetou).
